CONCRETE DURABILITY INSPECTION AND TESTING AT SCHOOL BUILDINGS STRUCTURE

Carlos Mesquita, Eng.
Oz, Lda / Technical Director

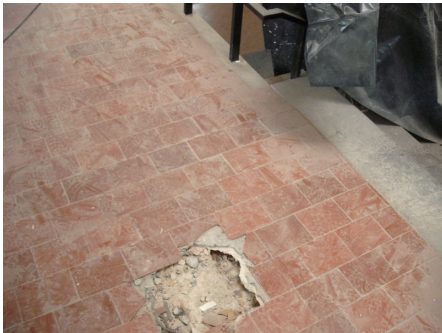
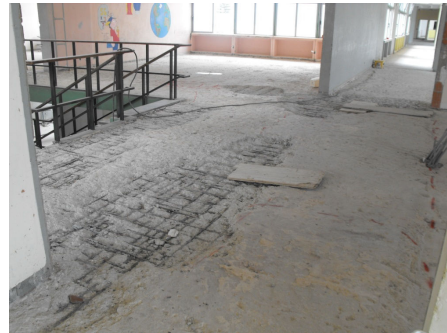
- diagnosis study of the reinforcement corrosion of a secondary school buildings structure, which was commissioned following the remodeling works of another school, with identical characteristics, involving specific work, **not foreseen**, structural repair at upper floors slabs due to **concrete contamination by chlorides**, which resulted in **extra costs too high**

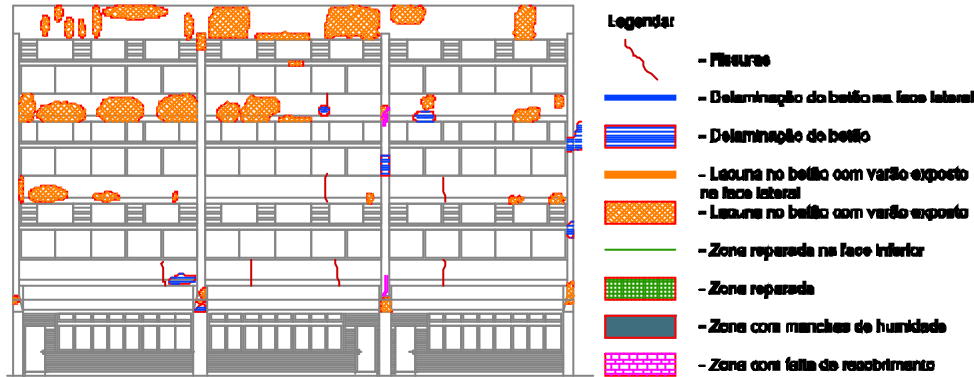
- **detection, identification** and **assessment** of the **importance** of the **anomalies** related to reinforcement **corrosion**, such as, for example, **delamination cracks, small gaps**, with exposure of **corroded rebars** with possible section reduction

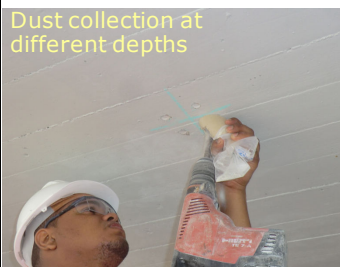
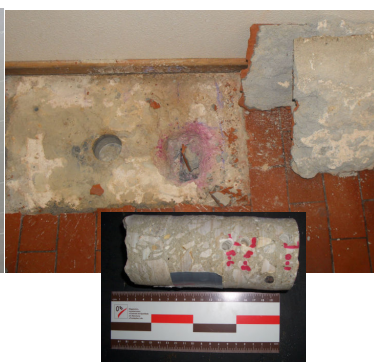
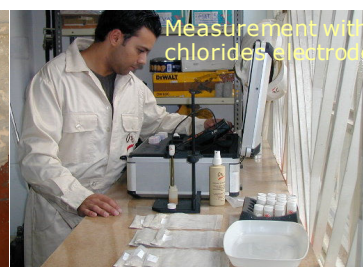
III. Evaluation of chloride content in concrete (prEN14629-2003)

- Tests were conducted on **powder samples** collected by drilling bit, up to three depths (surface layer, rebars level and behind the rebars). Were performed **8 tests**, 4 of which from the **cores**.

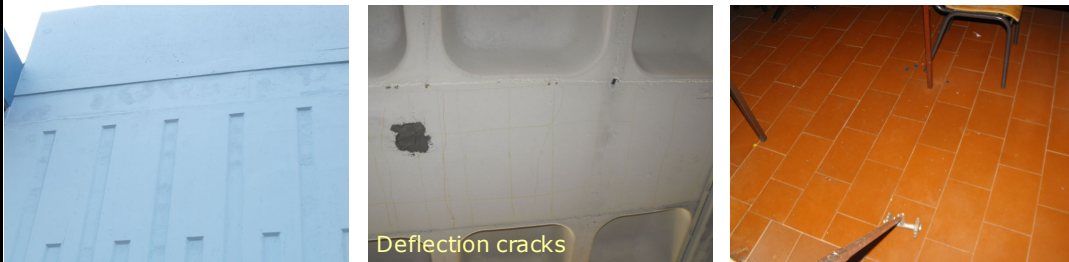
- the **façades**, which were **recently painted**, was detected frequent presence of **small surface irregularities**, whose features seemed to **repaired parts** of the structure due to **reinforcement corrosion**. Were located more frequently on the walls and, secondly, in the façades prefabricated elements.

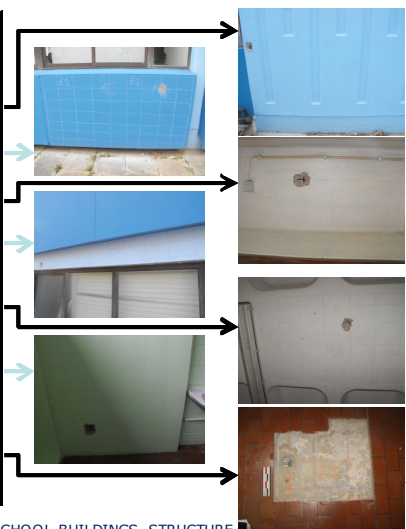
I. Measurement of rebar cover

Test Zones	Element	Cover measured with the covermeter (mm)					Carbonation depth (mm)
		min.	med.	max	S.D.	C. Var.	
1	B1/façade wall	10	30	49	11	38%	24
11	B3/façade wall	10	22	33	8	37%	14
2	B1/Prefabricated ext.	16	25	42	6	25%	9
12	B3/Prefabricated ext.	10	34	48	7	22%	6
9	B1/Prefabricated int.	20	31	43	6	19%	25
17	B3/Prefabricated int.	21	26	30	3	11%	45
3	B1/s lab /Board	11	18	24	5	27%	19
10	B3/s lab /Board	16	18	21	2	11%	27
7	B1/Slab/ bottom face	7	14	21	4	27%	24
8	B1/Slab/ bottom face	18	22	26	2	11%	27
13	B3/Slab/ bottom face	8	14	25	6	43%	23
14	B3/Slab/ bottom face	11	15	20	2	15%	33
6	B1/column int.	18	35	49	9	26%	4
16	B3/column int.	23	29	41	5	17%	30
4	B1/Slab/ upper face	67	68	69	1	2%	3
5	B1/Slab/ upper face	70	71	72	1	2%	5
15	B3/Slab/ upper face	70	83	92	8	9%	4
18	B3/Slab/ upper face	60	64	67	3	4%	3
19	B3/Slab/ upper face	40	40	40	0	0%	2

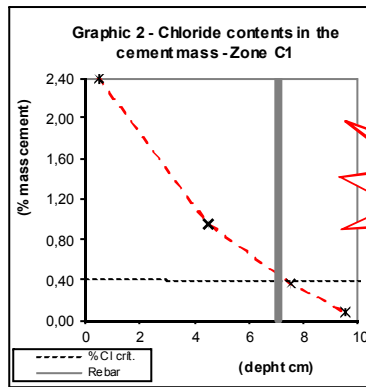
III. Evaluation of chloride content in concrete

- the chloride contents of the **slabs upper face**, very consistent, are **mostly higher** than the critical value indicated in the standard NP ENV 206 of 0,4 % of the cement mass

CORROSION HIGH RISK

• It was concluded that **slabs top face** at upper floors was the **most severely compromised** structures part, susceptible to **severe and rapid deterioration**, due to reinforcement corrosion, provided by **high levels of present chlorides**.

• The **repair durability** of the corroded reinforcement of upper floors slabs (roof excluded) must be the **maximum possible**. Accordingly, in addition to repair of visibly affected areas have to be eliminated salts in excess of concrete by means of **electrochemical treatment of desalination** or alternatively choose the introduction of **cathodic protection of reinforcement**, immunizing them of corrosion.
